GULLY FORM AND DEVELOPMENT ON KAROO SEDIMENTS IN CENTRAL ZIMBABWE: A PRELIMINARY SURVEY

R. WHITLOW

Department of Geography, University of Zimbabwe

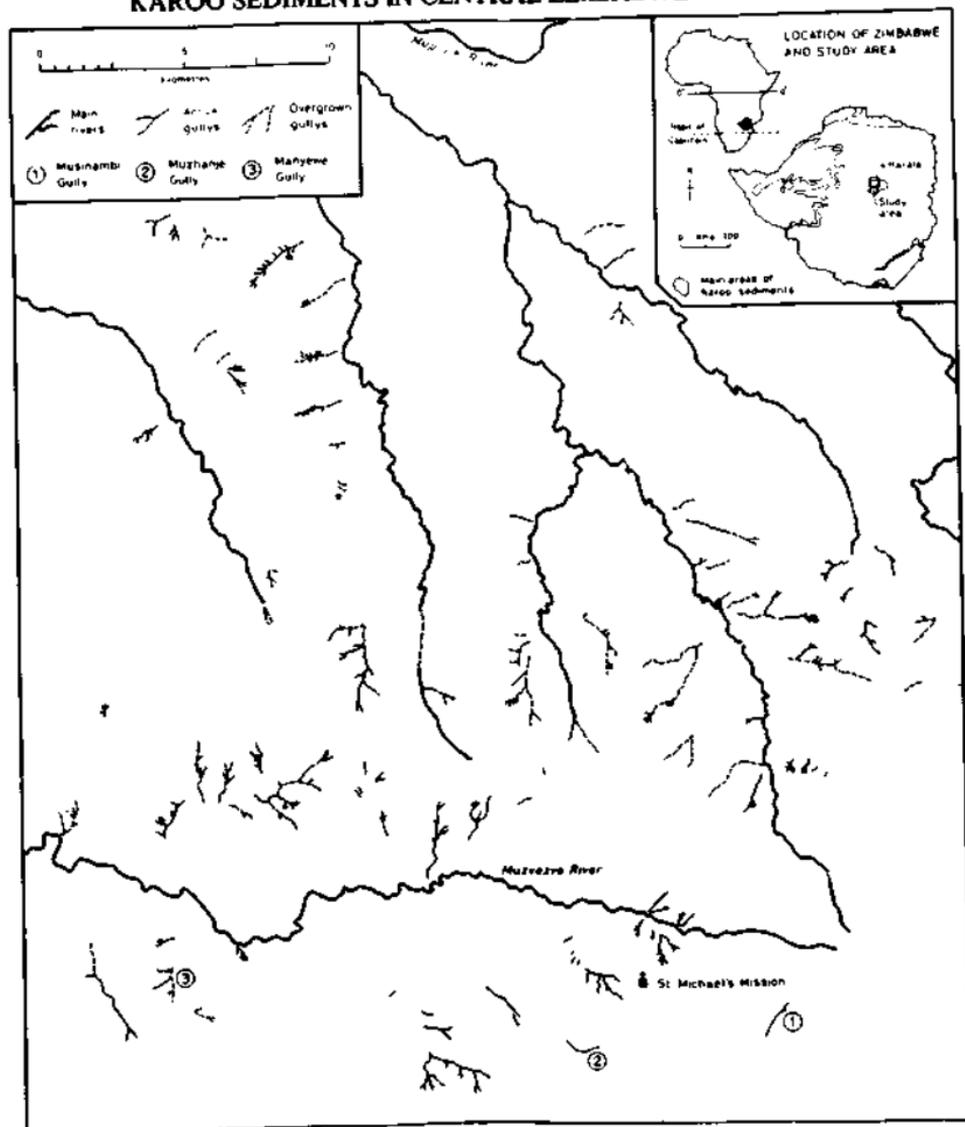
Figure 1: DISTRIBUTION OF ACTIVE AND STABILIZED GULLIES ON KAROO SEDIMENTS IN CENTRAL ZIMBABWE

half of the area underlain by Karoo sediments (Fig. 1 inset). More detailed mapping of this western area was carried out using 1:50 000 topographical base maps and 1:25 000 aerial photographs taken in 1976. The results of the survey are presented in Figure 1.

A total of 116 gullies or gully segments (where active and stabilized channels were linked) were identified, of which 62 appear to be active and the remainder

two active gullies and one stabilized gully in the south of the study area, the local names for these sites being indicated in Figure 1. Gullies were chosen in this locality primarily because of the availability of 1:25 000 scale false colour imagery taken as part of an FAO/UNDP programme in May 1986. Field maps based on 15 \times enlargements of this imagery were drawn up prior to fieldwork and proved invaluable in the selection and location of cross-sections for surveying. Five other active gullies were examined briefly to ensure that the surveyed features were typical of the gullies in the area.
